September 10, 1987

FROM: Frank J. Filas, Reclamation Engineer

RE: Site Inspection, Brown Rose Mine, SM/015/036

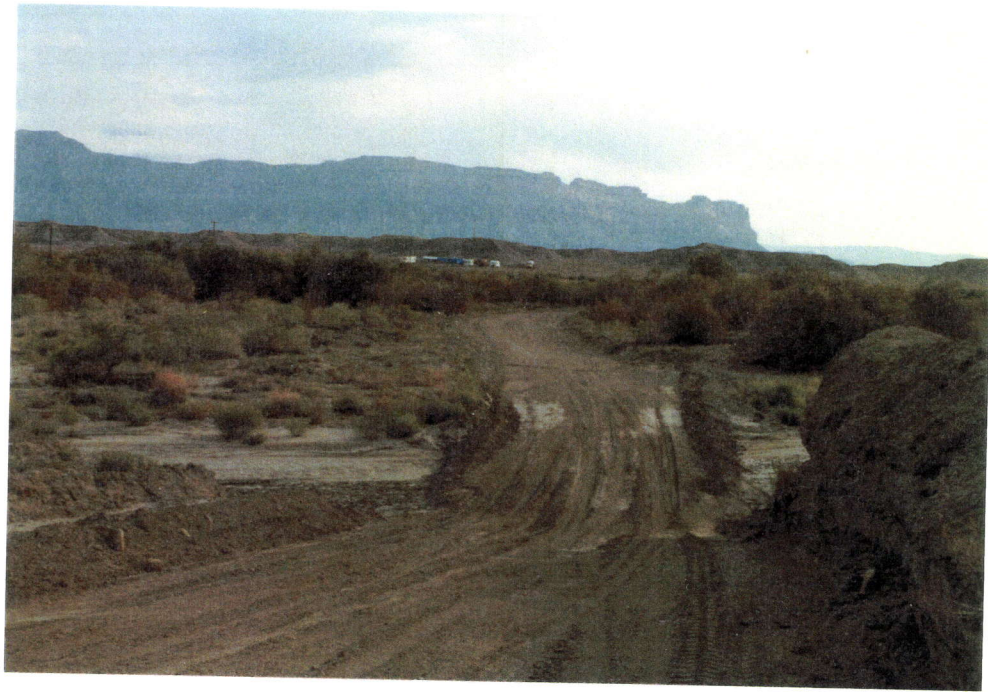
SM/015/036

The low hills in back of processing site is where the manros will be mined.

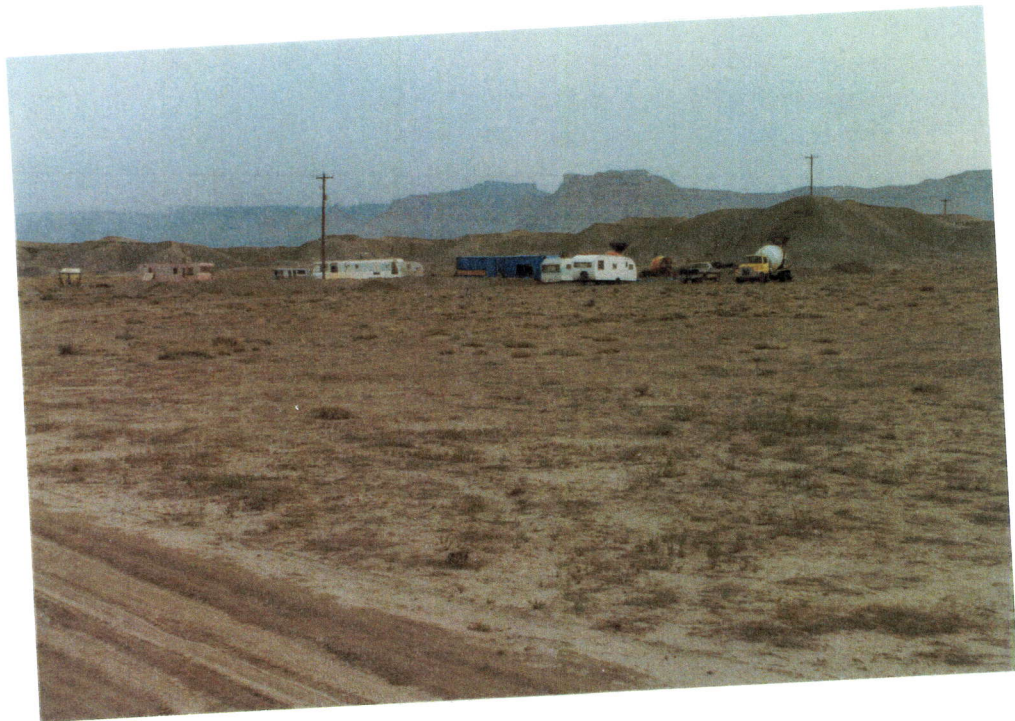
Brown Rose Mining Co.  
SM/015/036

The low hills in back of processing  
site is where the manros will  
be mined.
